Log Roads to Light Rails: The Evolution of Main Street and Transportation in Buffalo, New York

LOG ROADS TO LIGHT RAILS: THE EVOLUTION OF MAIN STREET AND TRANSPORTATION IN BUFFALO, NEW YORK

In June 1980, during initial construction of Buffalo's Light Rail Rapid Transit System, parallel logs were discovered 1.5 meters below the present street surface in downtown Buffalo, New York. Preliminary investigations suggested that they were part of a log or plank road used sometime during the first part of the 19th century, and as such represented a significant historic resource (Vandrei and Nagel 1980). Subsequently, the site was declared eligible for inclusion in the National Register.

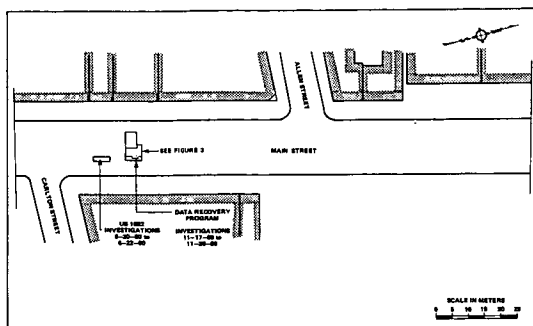
Figure 1. Placement of Excavation Units at the Buffalo Log Road Site (UB 1682).

Data recovery operations began as an "L"-shaped excavation unit which covered an area of about 38 m² and was located approximately in the middle of Main Street (Figure 1). Size and placement of the excavation were governed by the following objectives: to uncover as complete a section of the log road as possible; to open an area adjacent to the log road surface in order to identify any additional features; and to place the excavation unit in such a way as to allow free flow of two lanes of traffic at all times.

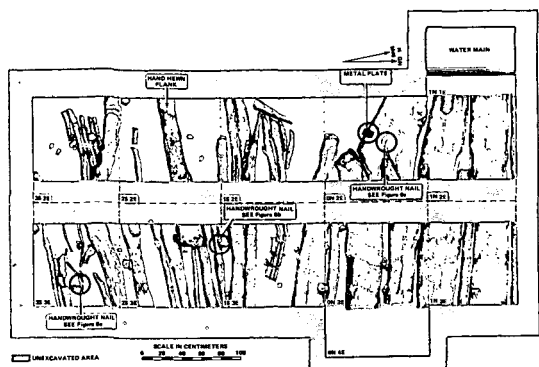
Figure 2. Plan Drawing of the Log Road.

Removal of the organic layer indicated that in one instance the space between the logs had been filled with a smaller branch or log (Unit 1N 3E, Figure 2). Apparently, an attempt had been made to fill in the space between the larger logs prior to the addition of the organic material to the road surface.

Most of the logs showed no evidence of having been intentionally hewn to make a smoother road surface. A single exception was a hewn plank uncovered in excavation unit 2S 2E (Figure 2). Since this plank was the only one of its kind recovered, it is believed that its use as part of the log road was secondary. All logs were placed perpendicular to the flow of traffic, and were roughly parallel to each other. There was no evidence that the logs were tied together; they were simply held in place by their own weight.

The logs varied in size and diameter. Those excavated in preliminary investigations were fairly consistent in size, ranging in diameter from 15 to 30 cm. (Vandrei and Nagel 1980:9). However, the diameter of the logs and branches excavated during data recovery ranged from 2 to 40 cm. The diameter of the logs generally decreased from north to south across the overall excavation unit. This size differential may best be explained if the portion of the road excavated was at the southern end of a larger causeway. The larger logs were likely those placed in the wettest area. In fact, these logs were embedded in a gray silt and clay deposit. The smaller pieces were probably laid over a drier area. Soil borings showed that the gray silt and clay deposit was shallower at the southern end of the excavation than at the northern end. Smaller pieces of wood were also embedded deeply in the clay deposit and several branches were covered with the clay, suggesting that they were forced into the ground as a result of heavy pressure from use. A few branches, as illustrated in units 3S 2E and 3S 3E, were overlain by larger branches, suggesting that attempts were made to build up the surface of the smaller branches (Figure 2).

one case where an odd "V"-shaped tree trunk was used, another log was closely fit next to it (Unit ON 2E; Figure 2). Smaller branches were placed between larger logs to make as smooth a surface as possible before an organic layer was added. Excavation showed that a 2 to 5cm. thick deposit of organic material was then placed over the log surface. The nearest available trees were used to construct the causeways. Preliminary identification of log samples indicates that cedars and other hardwoods indigenous to poorly-drained areas were used. A complete stratigraphic sequence of road building was not uncovered during the field investigations. The historic research indicates that gravel, macadam, and plank surfaces were used also on parts of Main Street. Although portions of what may have been a macadam surface have been observed while monitoring construction activities in other areas of Main Street, no evidence of a plank or gravel surface was noted. However, despite the nature of urban development, historic resources can still be found in an undisturbed setting. The stratigraphic profile serves to graphically illustrate extensive fill sequences that can occur in many urban areas. Historic fill not only serves to conceal historic resources but to protect and preserve them.

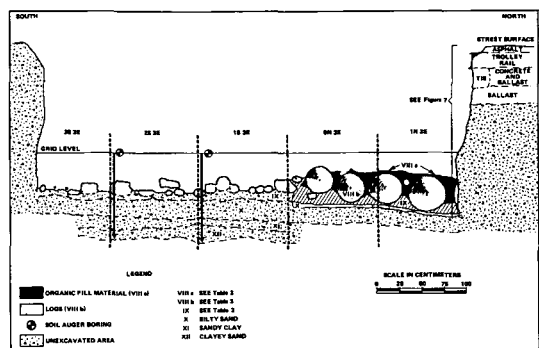
Figure 3. General Cross Section of Excavation Unit.

(Figure 3). The organic material did not, however, extend beneath the logs. This layer is apparently the earth mantle placed over the logs described by Ellicott (Bingham 1937:337-338).

eastern side had been cut by another modern trench (Figure 3). As a result, only 2.1 meters of the log feature remained undisturbed. Test units placed west of the modern trench failed to locate any additional evidence of the road. No excavation was possible east of this line.

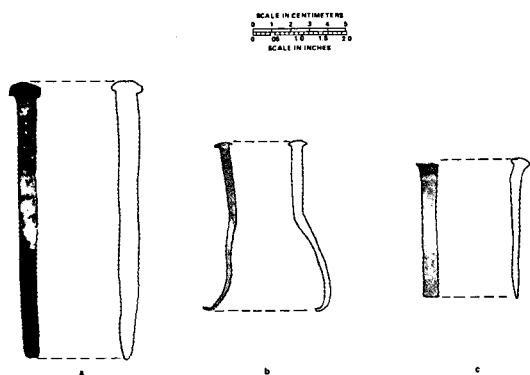
Figure 4. Handwrought Nails Found in Association with Log Road

Metal artifacts comprise the largest category of indentifiable materials, and provide the most reliable chronological information since they were the artifact type most frequently found in association with the log pavement. Nine metal artifacts were recovered; all but two appear to be iron. Six of these items are nails or spikes, two of which were recovered from the backhoe spoil during early excavation. These two spikes are modern steel railroad spikes, probably associated with the electric railway which operated along the center of Main Street. Of the remaining four nails, three were found in direct association with the log pavement. The one nail not associated with the road appears to be a farrier's shoeing nail, possibly handwrought. All of the remaining nails are handwrought iron types of various sizes and configurations (Figure 4). One is a large wrought spike. With the onset of cut nail production, the manufacture of such wrought nails began to decline in the early 19th century; thus the nails may be dated generally to this period of time (Noel-Hume 1969:252-254).

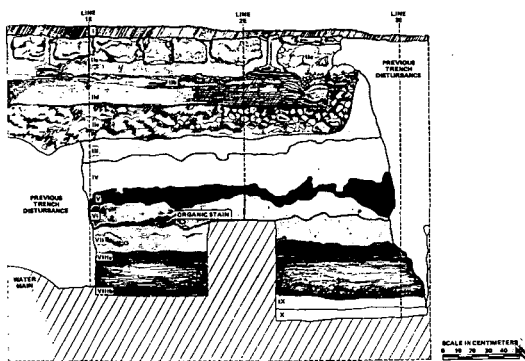
Figure 5. Profile of North Wall of the Excavation. See Table I for stratigraphic descriptions

Figure 5 illustrates the profile of the north wall of the excavation from the present surface of Main Street to beneath the log road. Descriptions of the eleven strata identified in Figure 5 are included in Table 1.

The stratigraphy illustrates a general historical sequence of road construction on Main Street over the last 180 years. At least nine distinct strata were recognized in the north wall profile. These strata, identified by Roman numerals in Figure 5, represent separate chronologically distinct deposits. Separate components recorded within two of the strata (Strata II and VIII) are identified by lower case letters.

Stratum II. This stratum represents the road surface and remnants of the trolley car system which operated on Main Street from about 1890 to 1950. Five separate components of this stratum are identified in the profile. These components illustrate how the road surface of Stratum II was constructed.

IIe) was first laid over the ground surface. As seen in the profile, a portion of the ground may have been excavated in order to provide a level bed for the route. The eastern end of Stratum III extends above the ballast on the east side of the trench wall, suggesting that a portion of this deposit was removed when the rails were laid.

Disturbances from utility trench excavations are illustrated in Figure 5. The most recent trench is shown on the east side of the wall profile. This trench, which was excavated during the summer of 1980, cuts through all of the stratigraphic levels. A portion of the log road was removed during excavation of this trench. The trench on the west side is much older and is the result of excavation of a waterline which runs down the center of Main Street. An examination of the profile reveals that this waterline was placed in the ground prior to the construction of the trolley line and the block stone road surface in the late 19th century. The trench cuts through Strata V through IX, but is overlaid by the undisturbed ballast (Stratum IV) of the trolley system.
